CIA/PIR-77042

KTANGNAN SHIPYARD

SHANGHAI, CHINA

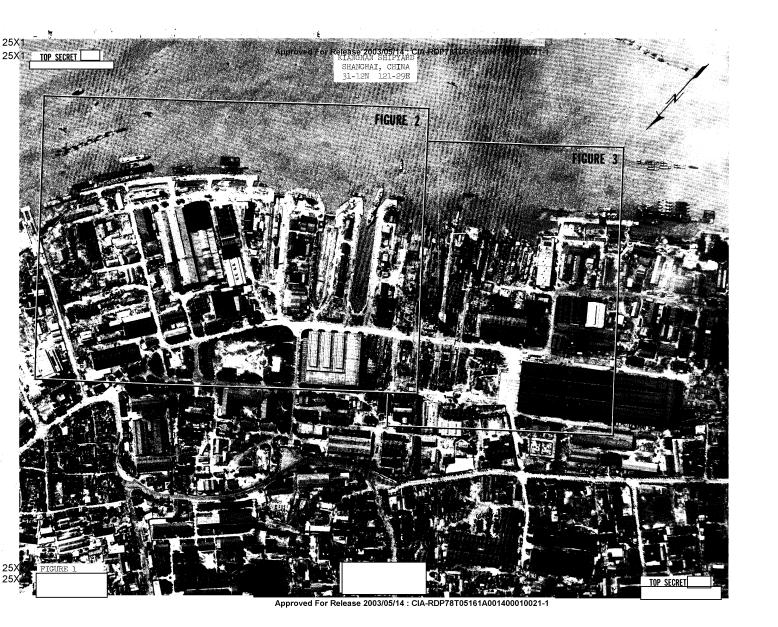
Approved For Release 2001/05/14/05/161A001400010021-1
	CIA/PIR-77042
LOC	TPYARD: KIANGNAN SHIPYARD SATION: SHANGHAI, CHINA COORDS: 31-12N 121-29E
	KEY TO ANNOTATIONS ON FIGURE 2

1.	KAIBOKAN Class PF hull (LOA approx 220'). This hull appeared to be stripped when it was seen on (see annotation 2, Figure 3, PIR-67221). Although the hull is still largely void of topside detail, the forward portion of the superstructure is now in place. This imagery equates to the original configuration of the KAIBOKAN I Class PF. A possible stack is also visible.

2.	Railroad Ferry (LOA approx 360'). See annotation 5, Figure 5,
3.	Unidentified possible passenger vessel (LOA approx 195').
4.	Floating crane alongside offshore wharf.
5•	Possible "R/W" Class SS (visible waterline length approx 250'). Rounded hull form and raised imagery on bow possibly equating to a sonar dome is visible. Light-toned imagery approximately in length can be seen on either side of the centerline of the submarine abaft the sail. A probable barge or camel is positioned between the offshore wharf and the submarine. A floating crane is operating outboard the submarine's por side.

6.	Unidentified probable merchant vessel in graving dock (LOA approx 205'). A small barge also occupies this graving dock. See annotation 4, Figure 4,
7.	Unoccupied graving dock.

8.	CASTLE Class OPF (LOA approx 250'). This vessel appears to have the conventional Chicom CASTLE Class configuration. Unidentified structures (probably temporary) are located on both the fantail and the foredeck of this ship. A probable CASTLE Class OPF was seen at Kiangnan Shipyard on (see annotation 17, PIR-67268). The vessel seen on that date appeared to have a different topside configuration abaft the superstructure.

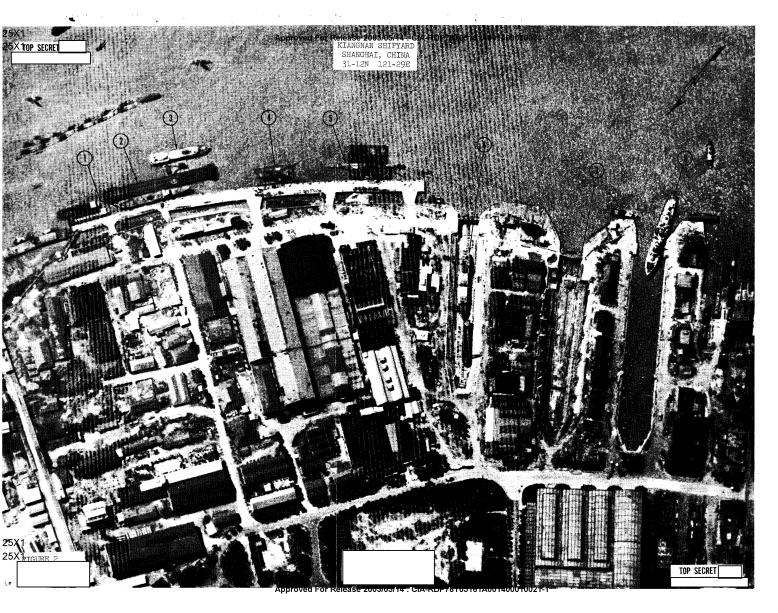
Large unidentified merchant ship under construction on building way (visible extent of construction approx 425'). See annotation 10, Probable components for this ship can be seen about the shipyard. Cylindrical object lying on its transverse axis (approximate maximum diameter 20'). See Figure 6, Possible cylindrical object lying on its transverse axis (diameter is roughly 20'). A total of eight cylindrical objects (two of which were identified as possible submarine hull sections) were visible within the security screer surrounding the submarine building ways in See annotations 4-7, Figure 6, Possible "R" Class SS under construction on building way (exact measurements of the SS cannot be determined - the length of the submarine including the weather sheds at each end is approximately 260'). This submarine appears to be in an advanced stage of construction - the sail appears in place and the deck is painted with a lengthwise dark stripe along the centerline. A small shed is positioned athwartships approximately 45 feet abaft the sail. See annotation 7, Possible tug on building way (LOA approx 100'). It cannot be determined whether this vessel is under construction or repair. This way was formerly used for the construction of an "R" Class SS (see annotation 5, Figure 3, small vessels were seen on this way (see annotation 6, small probable fishing trawlers on ways (LOA of each roughly 85-90') 	LOC	CATION : SHANGHAI, CHINA

ments of the SS cannot be determined - the length of the submarine including the weather sheds at each end is approximately 260'). This submarine appears to be in an advanced stage of construction - the sail appears in place and the deck is painted with a lengthwise dark stripe along the centerline. A small shed is positioned athwartships approximately 45 feet abaft the sail. See annotation 7, 5. Possible tug on building way (LOA approx 100'). It cannot be determined whether this vessel is under construction or repair. This way was formerly used for the construction of an "R" Class SS (see annotation 5, Figure 3, small vessels were seen on this way (see annotation 6, small probable fishing trawlers on ways (LOA of each roughly 85-90')	3.	roughly 20'). A total of eight cylindrical objects (two of which were identified as possible submarine hull sections) were visible within the security screen surrounding the submarine building ways in See annotations

It cannot be determined whether this vessel is under construction or repair. This way was formerly used for the construction of an "R" Class SS (see annotation 5, Figure 3, small vessels were seen on this way (see annotation 6, small vessels were seen on this way (see annotation 6, small probable fishing trawlers on ways (LOA of each roughly 85-90')	4.	ments of the SS cannot be determined - the length of the submarine including the weather sheds at each end is approximately 260'). This submarine appears to be in an advanced stage of construction - the sail appears in place and the deck is painted with a lengthwise dark stripe along the centerline. A small shed is positioned athwartships
	5•	It cannot be determined whether this vessel is under construction or repair. This way was formerly used for the construction of an "R" Class SS (see annotation 5, Figure 3, small vessels

6.	Four small probable fishing trawlers on ways (LOA of each roughly 85-90') See annotations 7 and 8 below.

TOP SECRET
	CIA/PIR-77042
	CIA IMAGERY ANALYSIS DIVISION
7.	Small vessel hull sections. Various bow, stern, and superstructure sections can be seen in this area of the shipyard. These sections equate to portions of the vessels seen at annotations 6 above and 8 below.

8.	Four small probable fishing trawlers on ways (LOA of each roughly 85-90'). See annotations 6 and 7 above.
	Probable "R" Class SS alongside camel at offshore wharf (visible waterline length approx 245'). A light-toned triangularly-shaped object appears to extend from the after edge of the sail - this could equate to the snorkel exhaust seen on "R" Class SS. An object possibly equating to the snorkel induction housing of an "R" Class SS can be seen extending from the top of the sail. See annotation 1, Figure 2,

10.	Unidentified probable merchant ship (apparent LOA approx 220').
11.	diameter inside diameter •
12.	Two unidentified, apparently circular, objects - one inside the other. The outside image has a maximum diameter of approximately the inside circle is approximately feet in diameter. These objects appear to be slightly higher, when viewed in stereo, than the adjacent cylindrical object (see annotation 11 above). It cannot be determined if these objects are cylinders.

13.	Three tapered objects, apparently semi-circular in shape, between craneway tracks leading to building way containing a possible "R" Class SS. One of these objects has a "notched-out" section on one side. Similar-looking imagery has been observed at the Wu-chang Shipyard, Wu-chang, China (30-32N 114-17E), in See bottom right caption, Figure 53, CIA/PIR-65038.
	KEY TO FACILITY ANNOTATION ON FIGURE 3
Α.	Transverser system has been extended from the possible turntable to a position in line with the craneway paralleling the down river side of the large building way containing the merchant ship under construction at annotation 1 above. Construction on the tracks and the possible turntable at the head of the craneways does not as yet appear to be completed. See annotation "C", Figure 2,
